Evaluation of a Leaf Spring Failure

C.K. Clarke and G.E. Borowski

The determination of the point of failure during an accident sequence of a rear leaf spring in a sport utility vehicle is presented in terms of fracture surface analysis and residual-strength estimates. Marks at the scene of the accident pointed to two possibilities for the point of failure: marks in the roadway at the start of the accident sequence and a rock strike near the end of the sequence. Evidence from rust and chemical contamination on the fracture pointed to the spring having been cracked in half prior to the accident. Extensive woody fracture and secondary cracking at the midplane of the spring was evidence for segregation and weakness in the spring. Stress estimates for the effect of both the weakness and prior cracking on the residual strength of the spring revealed reductions in strength of the spring that could produce fracture at the start of the accident sequence. The point of failure of the spring was placed at the start of the accident sequence.

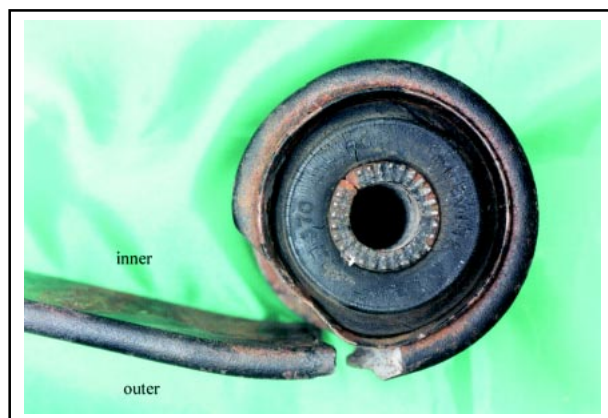
Fracture of the spring occurred at the formed forward eye, as shown in Fig. 1. Comparison of the eye with unbroken springs revealed that it had somewhat unwrapped prior to the failure. The position of the two broken ends in Fig. 1 exaggerates the prior deformation. Striking features of the fracture were the presence of extensive secondary cracking at the midplane, the stepped nature of the fracture, and “woody fracture” on the stepped surface parallel to the spring surface. Figure 2 shows the overall fracture with the secondary cracking. The

Fig. 1 The broken halves of the spring have been placed together in a manner exaggerating the opening of the eye before rupture.

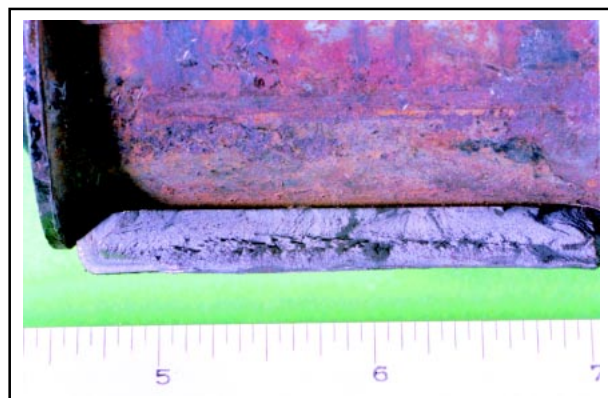
Fig. 2 The spring half of the fracture has deep secondary cracking along the midplane.

Figure 2 shows a distinct division of the fracture along the midplane. Stereomicroscopy revealed a step in the fracture surface at this location, with deep secondary cracking along 73% of the midplane. An old, rusty crack was also observed along the outside surface over most of the width of the spring. This old crack (arrows) is shown in a higher-magnification view in Fig. 3. The outer half of the fracture with the old crack was also observed to have rust, compared to the inner half. Figure 4 shows the inside fracture surface opposite that in Fig. 3. The outside surface clearly shows areas of rust, particularly along the old crack. The inner half of the spring fracture

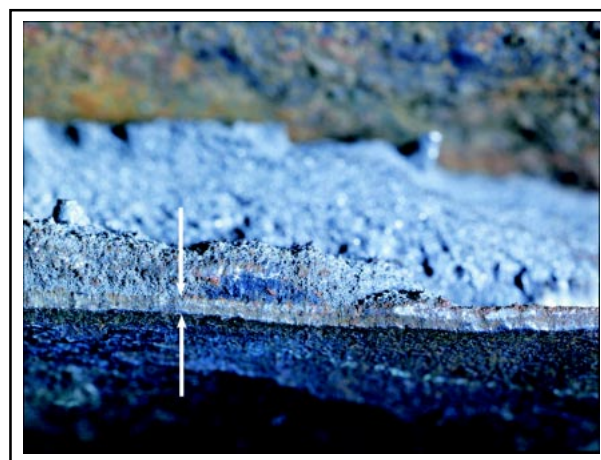
Fig. 3 The outer half of the fracture surface was observed to have rust in places. The old crack (arrows) along most of the outer surface is clearly rusted.

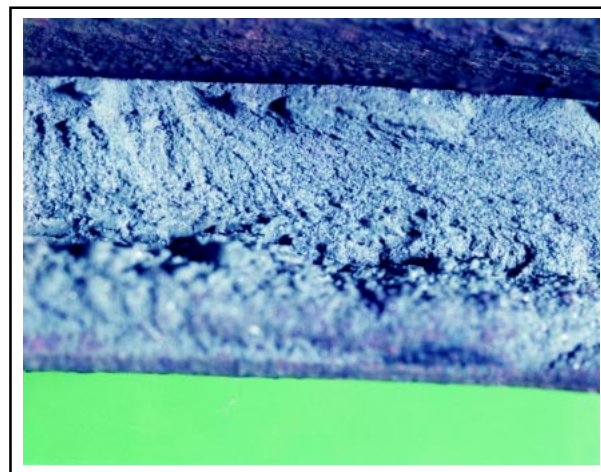
Fig. 4 This area of the inner half of the fracture across from the area in Fig. 3 is clear of rust.

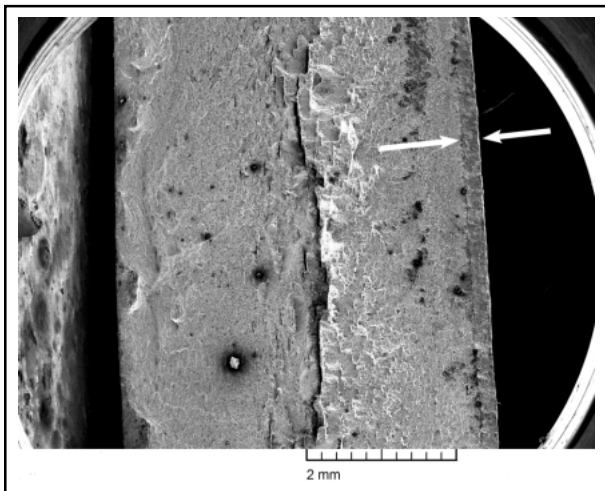
The SEM fractograph of the spring eye fracture in Fig. 5 clearly shows the midplane cracking and

Fig. 5 This area of the spring eye half of the fracture clearly shows secondary cracks at the midplane and an old crack (arrows) at the outside surface.

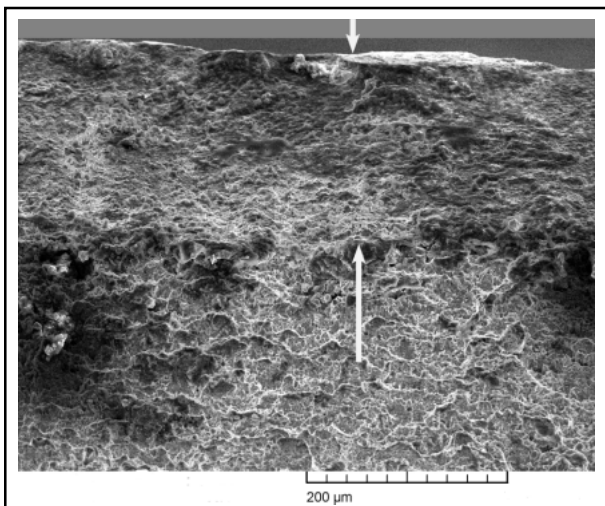
Fig. 6 More detail of the old crack (arrows) shows a rusted surface compared with fracture next to it.

old crack along the outside diameter (OD) surface (arrows). This old crack exhibited features indicative of a corroded surface, as can be seen in Fig. 6. Fracture between the old crack and the midplane was also rusted but less so than the old crack. The fracture mode in the old crack was difficult to see because of corrosion and physical damage. However, a few small areas were clear enough to reveal uniform, very small microvoids. Fracture between the old crack and the midplane was also by microvoid coalescence, but the void size was duplex with large and small microvoids. The fracture was also rougher.

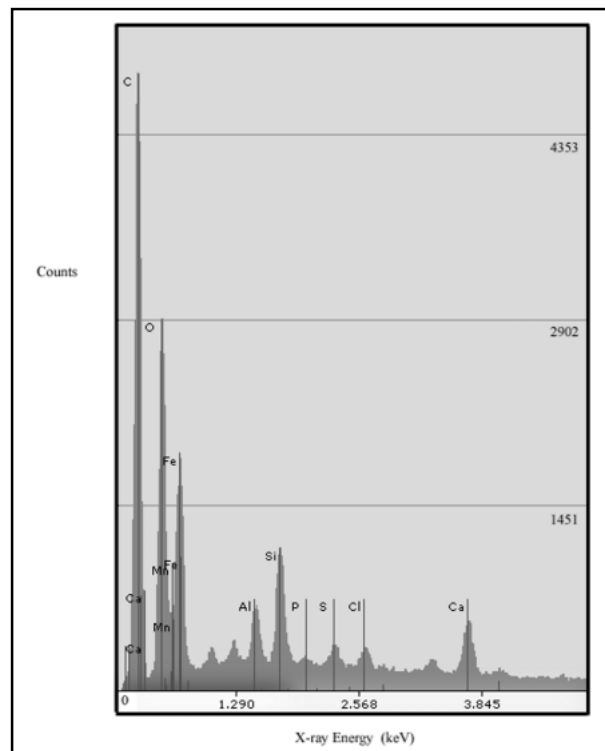
X-ray spectroscopy of the old crack in the SEM revealed unusually high peaks for oxygen, silicon, calcium, chlorine, sulfur, and aluminum. Figure 7 shows one of the X-ray spectra from the old crack.

Fig. 7 X-ray spectra from the old crack yielded high levels of carbon and oxygen. The other elements—calcium, aluminum, and silicon—are consistent with the road material. Chlorine can only be explained by ocean shipment.

obvious source for chlorine in this case was the known transport of the vehicle by an ocean-going ship. The high oxygen level is consistent with corrosion. The source of the sulfur is not known at this time.

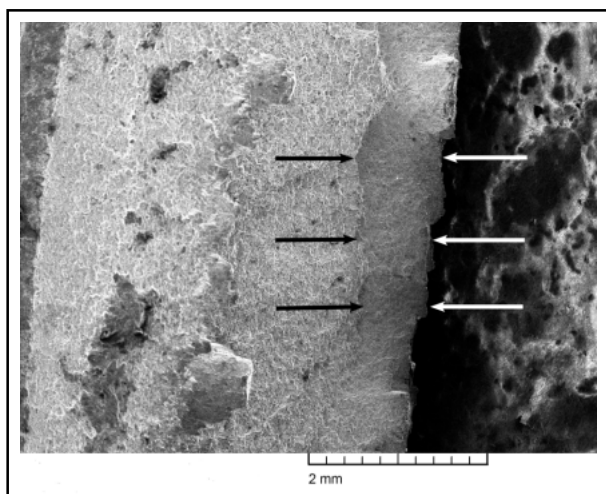
Figure 8 shows one area of “thumbnail-shaped” crack origins on the inside diameter (ID) surface. Chevron marks can be seen emanating from smaller thumbnails in Fig. 4. These regions were at an angle to the fracture and probably constitute a slow tear or low-cycle-fatigue-type feature. They triggered the final rupture of the spring.

Fig. 8 Chevron marks were observed propagating from the edges of these thumbnail areas (arrows) at the ID edge.

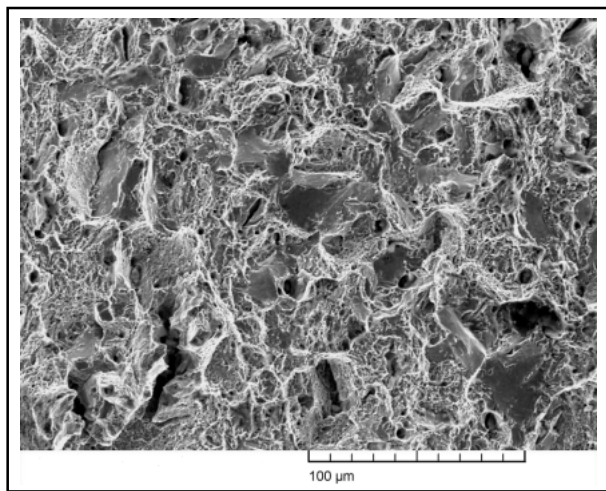
Fig. 9 This fracture area is approximately halfway between the inside spring surface and the midplane fracture. It is composed of a mixture of intergranular fracture (smooth areas) and microvoids.

the spring. Extensive intergranular fracture mixed with microvoids was observed in this region of the fracture. Grain boundaries in steel are stronger than the grains at normal operating temperatures,^[2] unless an element or compound develops on the boundaries and weakens them.^[3-5] Steels with this problem often exhibit lower toughness and are more sensitive to shock or rapid loading. There are a number of phenomena that can produce this problem. Leaf springs are normally hot formed, quenched, and tempered. Prolonged cooling through or tempering at certain temperature ranges can produce temper embrittlement that can result in the observed intergranular fracture. Under the proper conditions, sulfides can also penetrate grain boundaries as thin films and produce intergranular fracture at elevated temperatures.

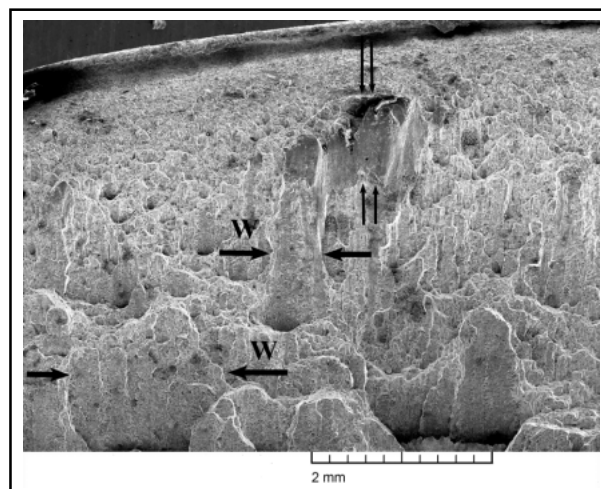
Fig. 10 The fracture has been tilted to show woody fracture (W). Double arrows point to rubbing damage on woody, secondary fracture.

ited strong peaks for silicon, carbon, oxygen, aluminum, and chlorine. Because the electron beam for X-rays was focused only on the smooth, rubbed surface and the fracture was solvent cleaned, the elements present in these strong peaks must come from contamination ground into the rubbed surface.

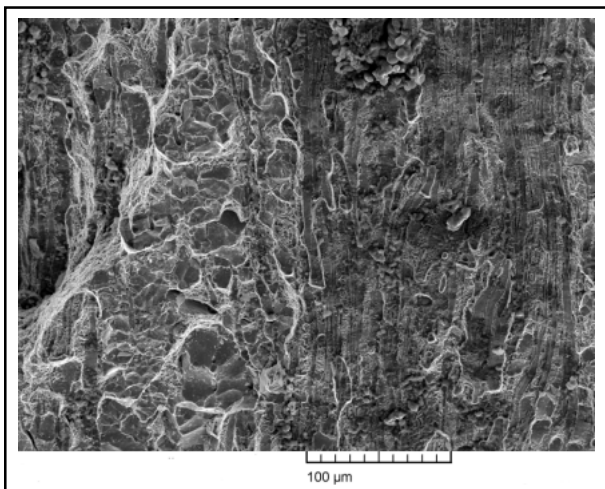
Fig. 11 This higher-magnification view of the woody secondary fracture shows that intergranular fracture is also associated with it.

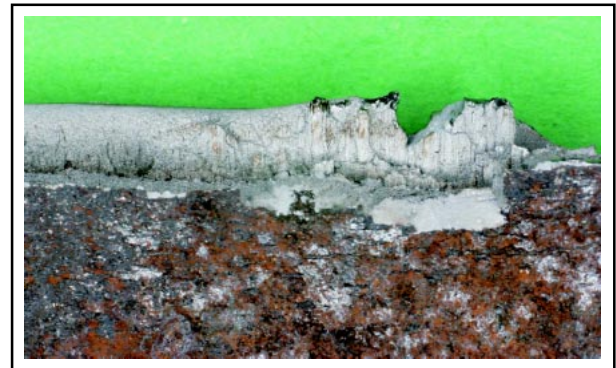
Both springs fractured at the forward eye in the same location and fashion as the accident spring. Spring B fracture exhibited more of the woody fracture and secondary cracking at the midplane than spring A. Figure 12 shows some of the woody fracture on spring B.

Fig. 12 Woody fracture at the midplane can be seen in this view of fracture in exemplar spring B.

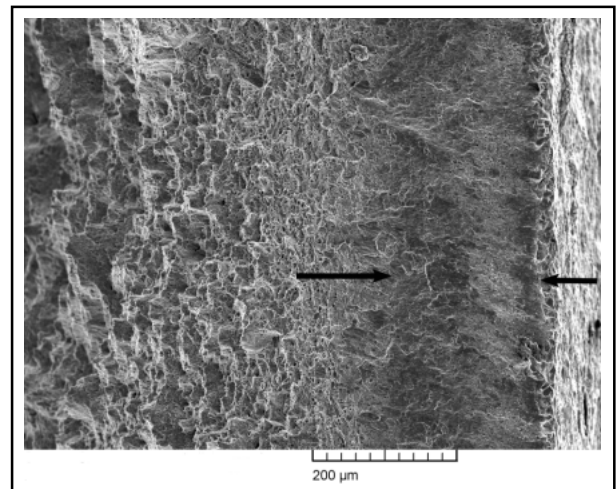
Both springs exhibited a distinct band on the fracture surface along the OD side in the same location where the existing oxidized crack was observed in the accident spring. Figure 13 shows this band on

Fig. 13 An outside rim (arrows) was observed in the fracture of exemplar spring B. This is the same location as the old crack in the accident spring.

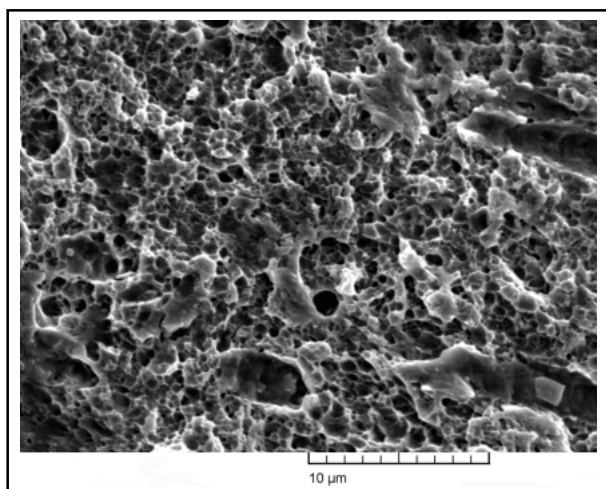
the exemplar spring B, where it was more pronounced. Fracture to the inside of the band was rough and consisted of large and small microvoids. Much of the fracture in the band was damaged, but small, protected areas in the band revealed very fine microvoids, as seen in Fig. 14.

Fig. 14 Very fine equiaxed microvoids could be observed in undamaged areas of the OD band fracture. While microvoid formation is a ductile or plastic mechanism, the macroscopic ductility or toughness of this type of fracture with very fine microvoids is low.

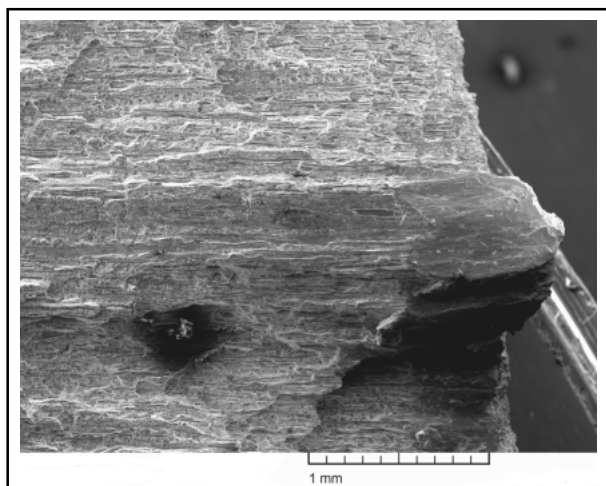
faces (accident and exemplar) exhibited small damaged areas on the woody fracture. Figure 15 shows an area of woody fracture with surface damage similar to that seen in the accident spring. However, higher-magnification examination revealed evidence for a single contact compared to repeated rubbing observed in the accident fracture. X-ray spectra from this damaged area on the exemplar fracture yielded none of the contamination observed in the accident spring.

Fig. 15 Damaged areas were observed on the woody fracture in the B spring, as in the accident spring.

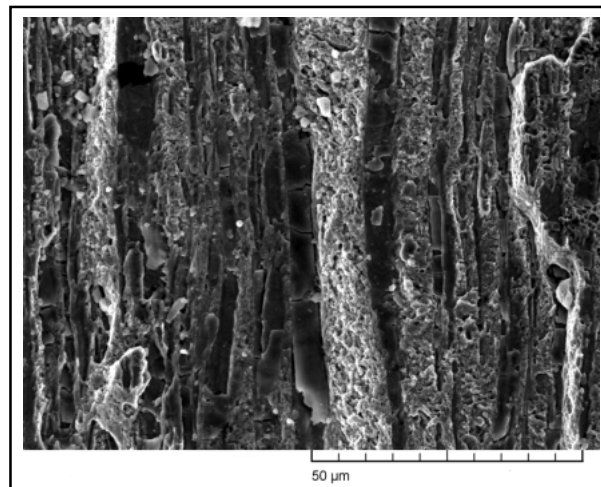
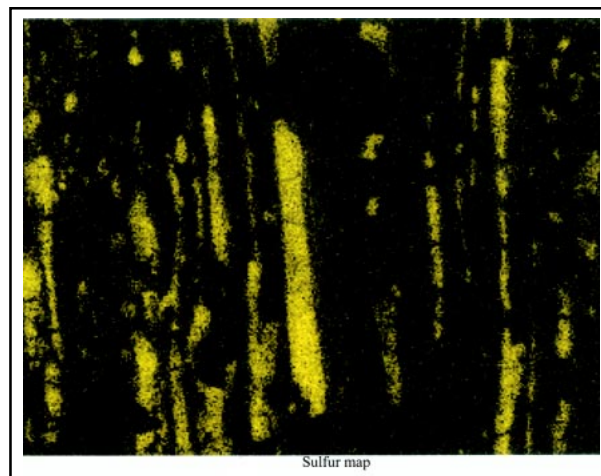
Fig. 16 An area of woody fracture. The X-ray map of Fig. 17 can be superimposed over this micrograph.

Fig. 17 This map of the area in Fig. 16 was made with sulfur X-rays only. This clearly shows the role of sulfur inclusions in the midplane woody fracture.

17 show that the woody fracture is associated with manganese sulfide inclusions. Figure 16 shows an area of woody fracture. Figure 17 is a map of the sulfur X-ray signals coming from the same area as in Fig. 16. Sulfur coincides with obvious inclusions and some that are not obvious. Manganese also yielded the same map. While the inclusions are very fine, their planar extent is substantial.

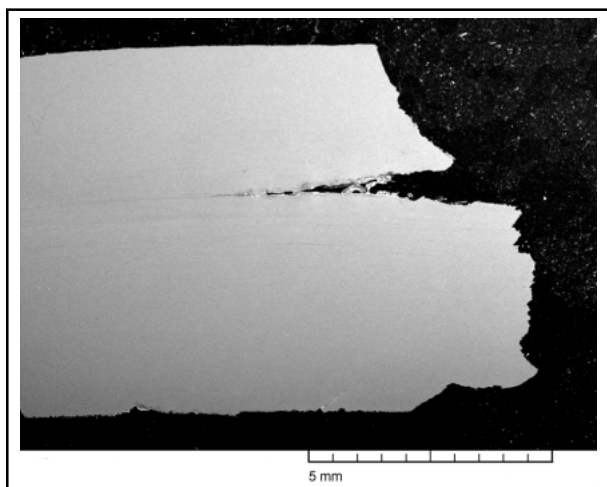
Cross sections were cut through the woody fracture. Figure 18 shows the midplane cracking in spring B. Optical microscopy revealed the midplane cracking to be associated with banding in the microstructure. Figure 19 shows the tip of the midplane crack in spring B to be associated with a white band with elongated inclusions. (Heavy etching to bring out the band obscured the inclusions.) Numerous fine, elongated sulfide inclusions were observed in these bands.

Fig. 18 Cross section of the fracture in spring B. The midplane fracture is very pronounced.

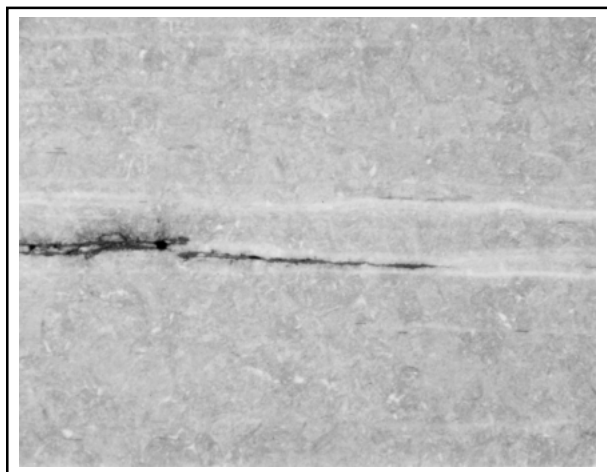
Fig. 19 The tip of the midplane crack in spring B follows a white band.
