A metallurgical analysis to determine the cause of a fire

Evaluation of fire damaged copper wire

C.K. Clarke

Metallurgical Consulting Inc.
Mobile, Alabama

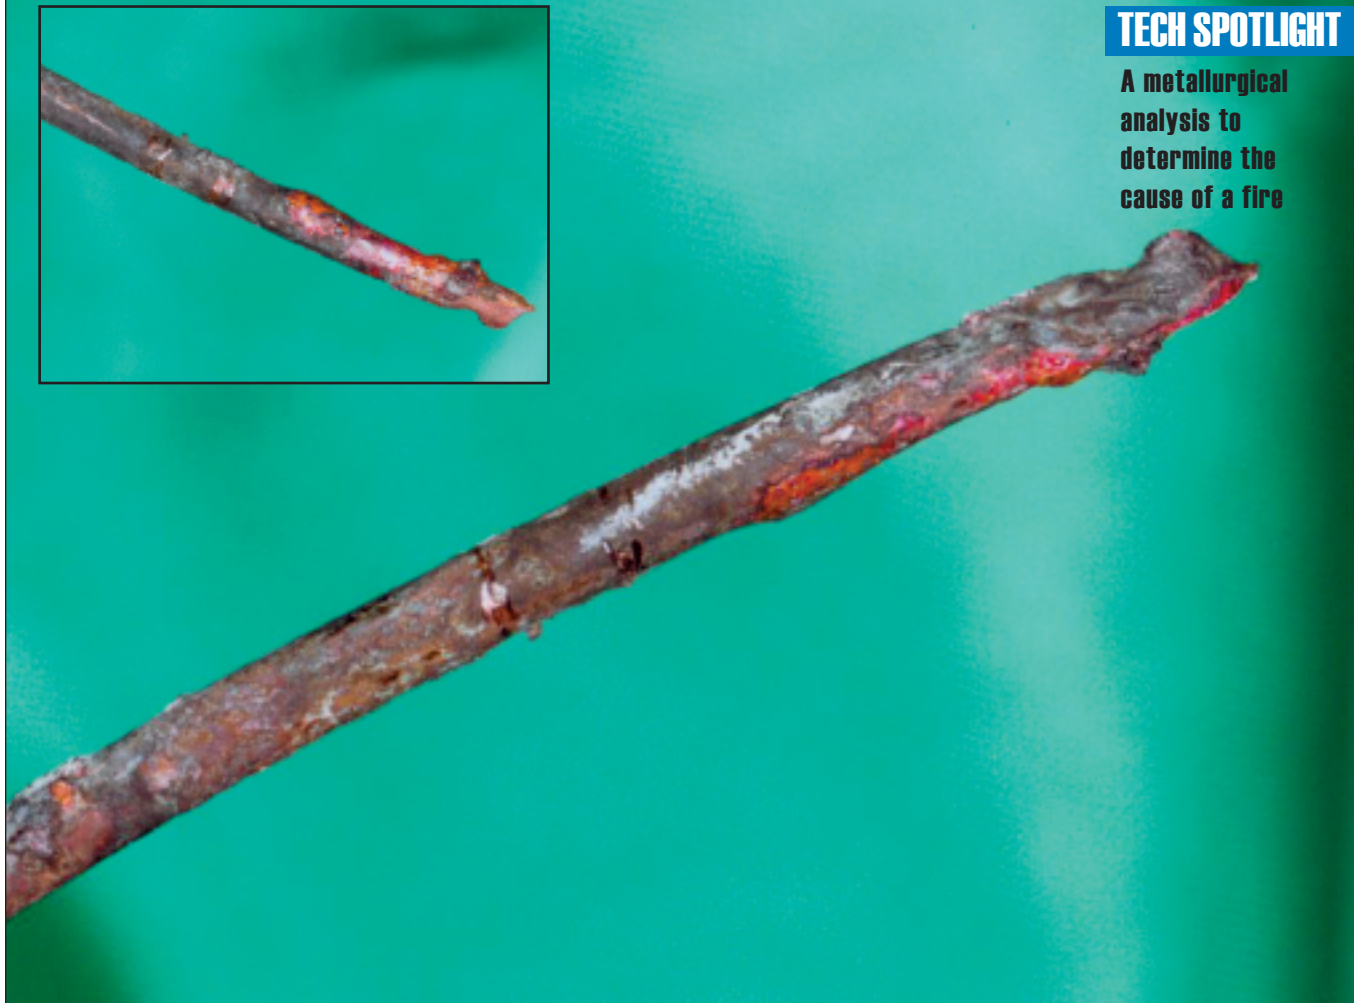
Fig. 1 and 2 (inset) — These show two views of the wire end as it was received. All of the wire insulation had been burned away, as it was on most of the wire recovered. Material appears to have been blown away at the end of the wire.

Figures 1 and 2 show two views of the wire end as it was received. All of the wire insulation had been burned away, as it was on most of the wire recovered. Material appears to have been blown away at the end of the wire. (This is typical of arc damage from other cases. For example, Fig. 3 shows the broken end of a bare power

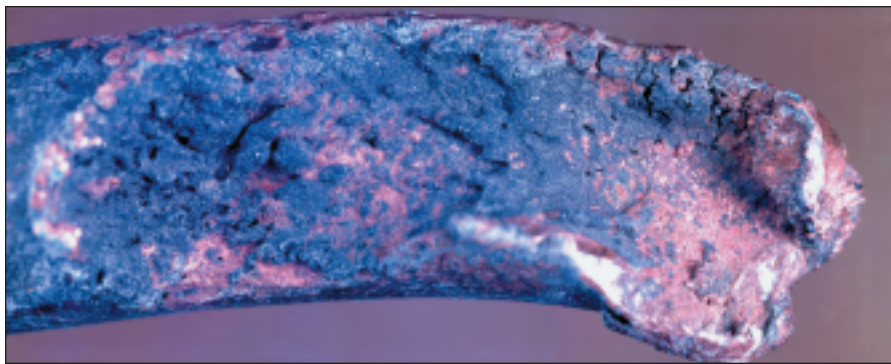
Fig. 3 — This is an image of the broken end of a power line that failed while carrying current.

line that failed while carrying current, although no fire was involved.)

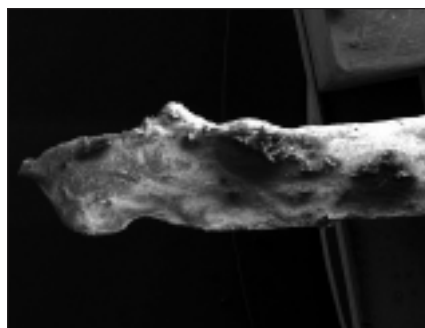
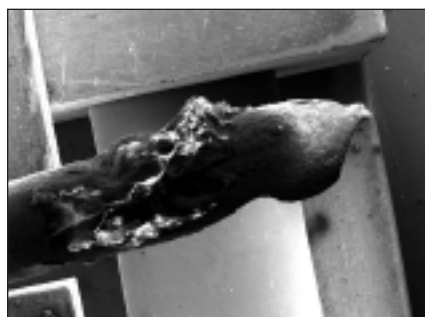
Fig. 4 (top) and 5 — These SEM photos show that a gray glass-like coating covered the rough surface that had lost material.

In the wire specimen from the fire, a gray glass-like coating covered the rough surface that had lost material, as shown in SEM photos in Fig. 4 and 5. X-ray analysis revealed that the film on the crater surface contained calcium and sulfur, which could be explained by gypsum wallboard. The rough surface shown in Fig. 5 is SiO_2 from the insulation.

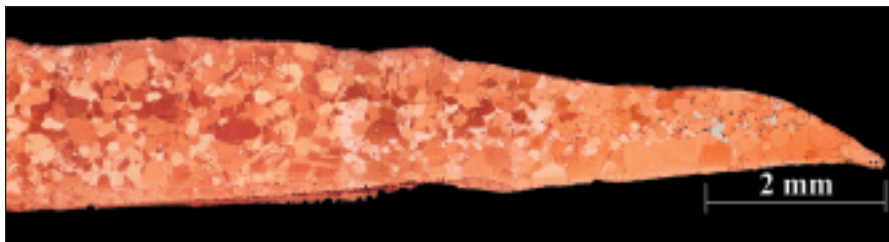
Fig. 6 — This montage shows the wire etched with dichromate, which gives better grain contrast than hydrogen peroxide.

Figure 6 shows a montage with the dichromate etch because of better grain contrast for reproduction of the photos. The hydrogen peroxide etch gave better detail of grain boundaries at higher magnifications, but both etches revealed the same grain sizes.

Several very large grains can be seen at the surface at the wire tip, but the rest of the grain structure is much smaller. For example, smaller grains can be seen at the far end of the montage, away from the tip. These smaller grains had many more annealing twins than the tip area. Because the original wire had been heavily drawn, the wire has clearly been heated and annealed in the fire. Figure 7 shows new wire for comparison.

Evidence for temperatures at or near the melting point for copper was observed in the tip area in Fig. 6, which shows a $\text{Cu}:\text{Cu}_2\text{O}$ eutectic structure and grain boundary liquation at the very tip. The eutectic melting point is 1066°C , and copper melts at 1084°C . Areas of eutectic are barely visible on the wire surface in Fig. 6 as a rough area on the straight surface. Higher magnification reveals the eutectic as a thin film covering the cratered area and some of the wire surface for a distance of 10.4 mm from the tip. Figure 8 shows the eutectic to be a classic rod-type structure. This eutectic structure was not observed in any of the rest of this wire sample or other wire samples from the fire.

The density of annealing twins was low in the large grains at the tip area of the wire shown in Fig. 6, and increased just beyond this area. Both grain size and density of annealing twins were relatively constant in the rest of the specimens from this wire.

twins at the wire tip is also evidence for higher localized temperatures. Annealing twins rarely occur in cast copper, but do develop in recrystallization annealing. Copper heated to 900°C (1650°F) does not appear to exhibit annealing twins. Therefore, temperatures away from the wire tip shown in Fig. 6 by approximately 10 mm or more were considerably lower. This also argues for a steep thermal gradient at the tip of the wire.

Fire damage or the extent of heat was extremely large compared to the short length (approximately 10 mm) shown in Fig. 6, which had evidence for much higher temperatures. All of the other wire samples exhibited evidence of a more constant, lower temperature than the tip area. No other known heat source was in the area, except for a parting arc that could account for the observed metallurgical evidence for steep thermal gradients.

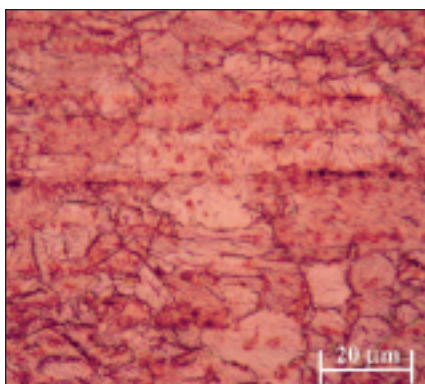
Fig. 7 — This is the microstructure of the new wire for comparison purposes.

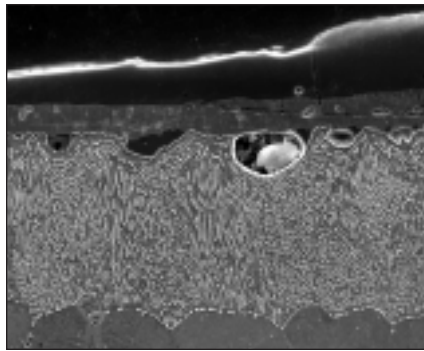
Fig. 8 — The Cu:Cu₂O eutectic shows the classic rod-type structure.

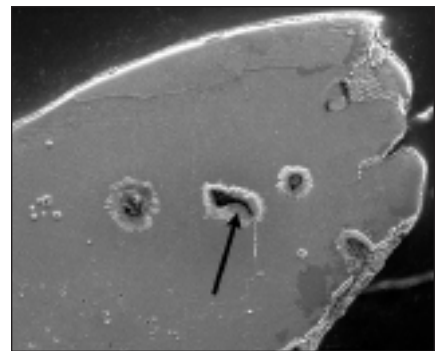
Evidence for grain boundary liquation can be seen at the very tip of the wire in Fig. 9 in one of the large voids at grain boundaries. Liquation is identified by the curved surface of one void ending at a grain boundary. (The fringe around the voids is etchant bleed-out.) Eutectic penetration at the very tip can also be observed. Grain boundary voids were found up to $200\ \mu\text{m}$ from the tip.

Fig. 9 — Evidence for grain boundary liquation can be seen at the very tip of the wire in one of the large voids at the grain boundary.

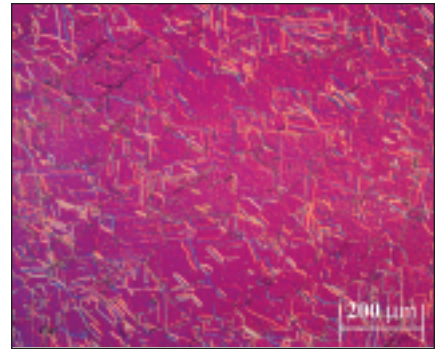
Figure 10 provides an example of the typical structure and density of annealing twins in this wire away from the tip. Differential interference contrast accentuates the twins.

Fig. 10 — This section of wire away from the tip shows the typical structure and density of annealing twins.

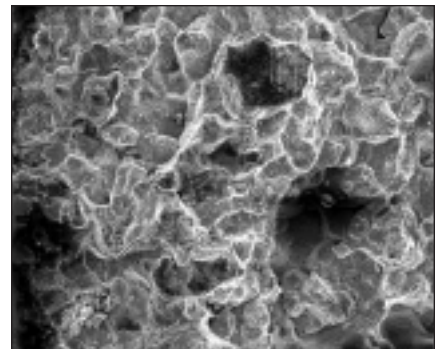
Figure 11 shows a brittle type failure from another wire recovered from the fire. The brittle failure results from rapid grain boundary penetration by oxygen at high temperatures and subsequent embrittlement.

Fig. 11 — A brittle mode of failure is shown in this wire, another recovered from the fire.

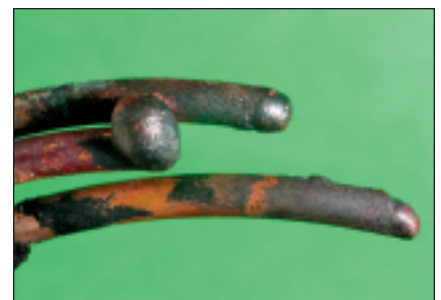
Figure 12 shows one of the melted ends resulting from attempts to produce a parting arc. Melting is very clear in the form of rounded and globular ends.

Fig. 12 — Melting is very clear in the form of rounded and globular ends in this wire that was subjected to attempts to produce a parting arc.
