Failure Analysis of a Pole Gin

C. Kendall Clarke

Lugs on a cast aluminum/fiberglass pole gin failed while raising an electrical transformer on a power pole. This same system had just lowered a heavier transformer. The pole gin consisted of a cast aluminum base that was strapped to a utility pole by a nylon belt-and-ratchet mechanism. A fiberglass pole was mounted in the base, and a pulley was attached to the other end through another aluminum casting. Rigging for the lift was complex and required a physical simulation to estimate actual lug hole loads and to determine that overall loading was within the manufacturer's published limits. Possible abuse by hammer blows was evaluated by dynamic testing to measure force attenuation in the system. Results ruled out abuse as a factor. Literature revealed that the heat treatable Precedent 71A, or A771-T7 alloy, used for the base casting was very susceptible to stress-corrosion cracking (SCC). Evidence was observed for features indicative of creep-rupture damage on the fracture surface. Evaluation of all of the evidence led to the conclusion that time-dependent crack growth, most likely by both SCC and creep-rupture, plus the effect of bo

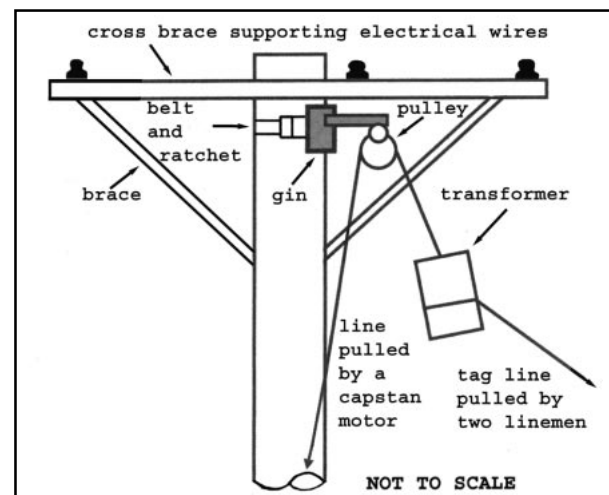
Fig. 1 Schematic arrangement of rigging for transformer replacement. The complexity of the rigging required experimental procedures to measure forces on the gin and lugs.

accident occurred. Rigging consisted of a single pulley attached to the pole gin end fitting (Fig. 1). A slow-speed capstan at the base of the pole powered the lifting rope. Phone lines on the side of the pole and just below the transformer required using a tag line, with two men on the ground to move the transformers over the lines. The pole gin was rated for 8900 N (2000 lb), with no restriction on loading direction.

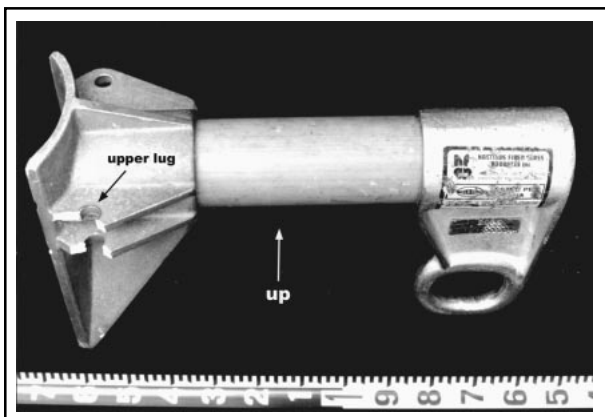
Figure 2 shows the overall gin, with two broken lugs where the 12.7 mm (0.500 in.) diameter bolt holding the ratchet pulled out. Figure 3 shows a scanning electron microscope (SEM) micrograph of the fracture surface at the hole wall in the upper lug. Intergranular fracture and microshrinkage can be seen up to the hole wall. No evidence of cyclic fatigue could be observed in any of the hole wall areas on either side of the hole wall in the upper lug.

Fig. 2 Two broken lugs where ratchet attached to base of pole gin

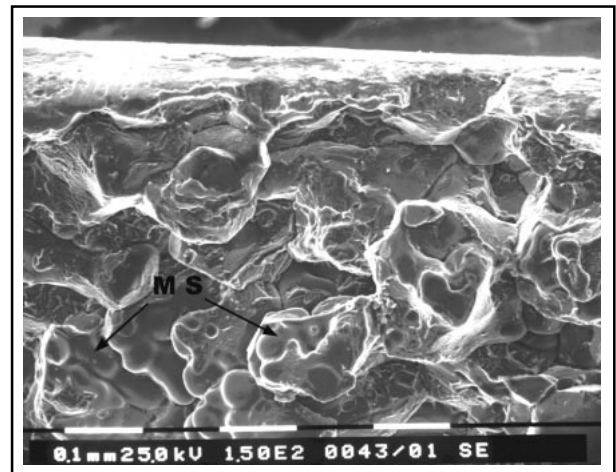
Evidence of intergranular fracture, microshrinkage, and triple-point-type grain-boundary voids are shown in Fig. 3 and 4. These features were characteristics of the fracture surfaces in both lugs on the gin. Intergranular fracture is evidence for a weakness in the grain boundaries, usually resulting from segregation of elements to the boundary surfaces. A precipitate pattern indicative of grain-boundary precipitation can be seen on grain-boundary facet surfaces in Fig. 5. A triple-point void (void at the juncture of three or more grains) can also be seen in Fig. 5. This feature is usually associated with creep-rupture failure mechanisms. Interdendritic porosity or microshrinkage is very obvious in Fig. 3 and 4. The triple-point void in Fig. 5 is not characteristic of microshrinkage. Dated and out-of-print company

Fig. 3 Intergranular fracture and microshrinkage observed at hole wall area on upper lug fracture

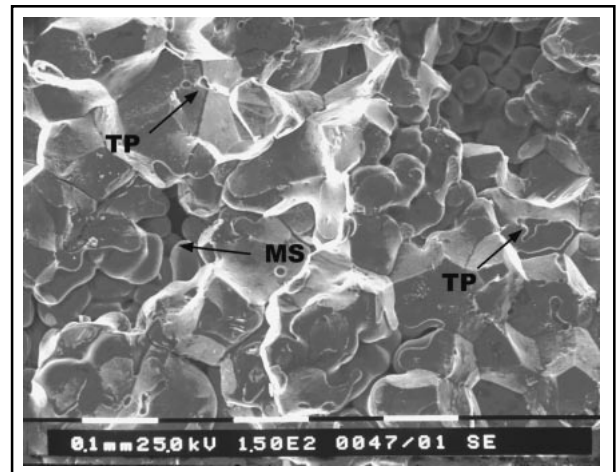
Fig. 4 Fracture area further in from origin area of Fig. 2 also shows intergranular fracture, microshrinkage (MS), and triple-point (TP) grain-boundary voids.

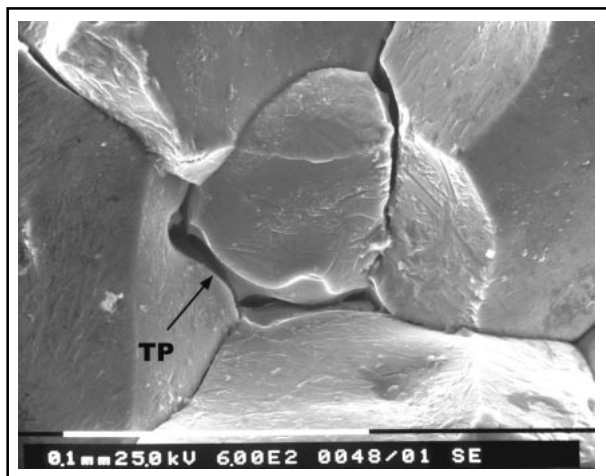
product literature warned of creep at room temperature at high stress levels with this alloy. Unpublished research by the author in the early 1970s on overload retardation in crack growth clearly revealed rapid room-temperature stress relaxation in 7075-T6 alloys. Therefore, it is quite possible that the triple-point void in Fig. 5 is actually a manifestation of a creep-rupture process in this alloy.

Fig. 5 Faint patterns on grain-boundary faces indicate grain-boundary precipitates.

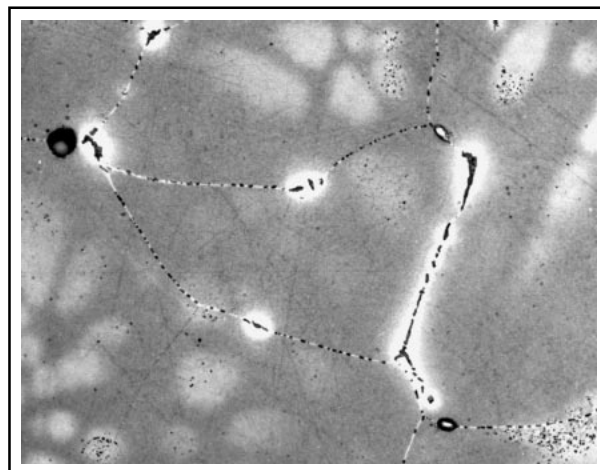
Fig. 7 A 2% sodium hydroxide etch revealed more detail of the grain-boundary precipitation.

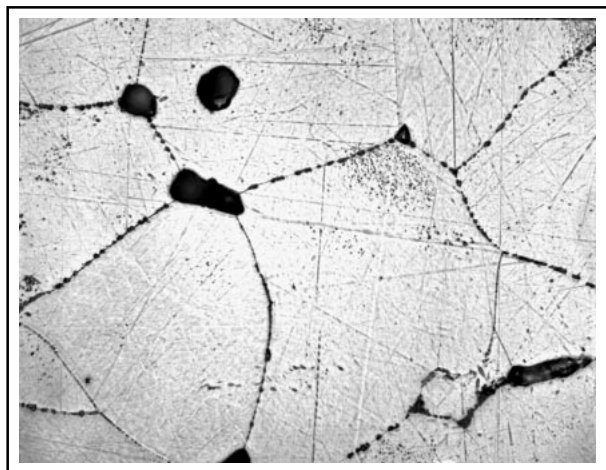
Specimens for metallography were cut just below and parallel to the fracture surfaces of the outboard lug cracks. Polishing was carried out with diamond abrasives on a napless cloth to reduce the risk of inclusion pullout. Figure 6 shows the two different types of grain-boundary precipitates that can be seen when using Keller's reagent. Sodium hydroxide etchant provided somewhat better resolution of the grain-boundary precipitation, as shown in Fig. 7. Nearly continuous grain-boundary voids are shown in Fig. 8. This is consistent with the observation of extensive void surface on the fracture.

Fig. 6 Large grain-boundary precipitates in upper left corner. Fine grain-boundary precipitates are present in most of the boundaries. (Keller's etch)

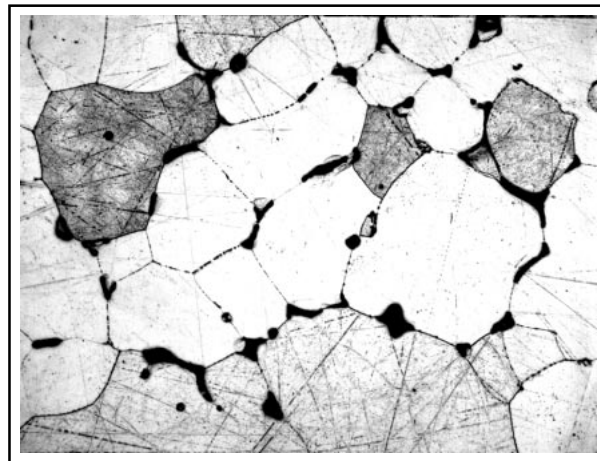
Fig. 8 Nearly continuous grain-boundary voids. This is consistent with the extensive grain-boundary voids observed on the fracture surfaces. (Keller's etch)

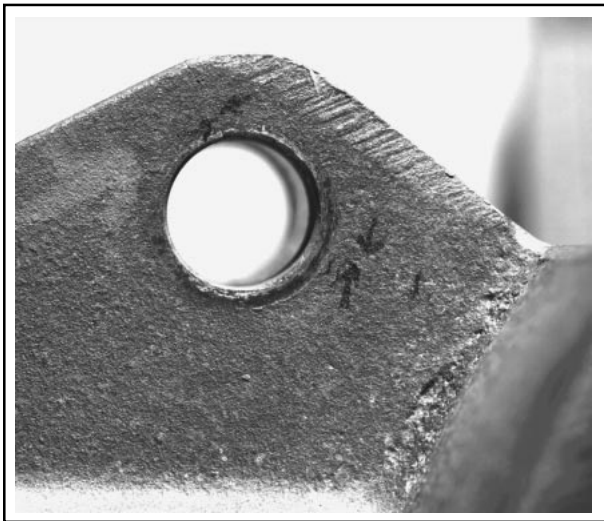
A second cracked pole gin was discovered during inspection of a group of gins returned from service. A crack in the outboard side of the upper lug hole wall could be seen visually (Fig. 9). A second crack propagating toward the base was not apparent until examined with a low-power microscope. Dye penetrant revealed that the second crack was much more extensive, as shown in Fig. 10. No cracks were found in the bottom lug.

Fig. 9 A second cracked gin from service was discovered to have two small cracks in the top lug only. Arrows on the surface point to cracks.

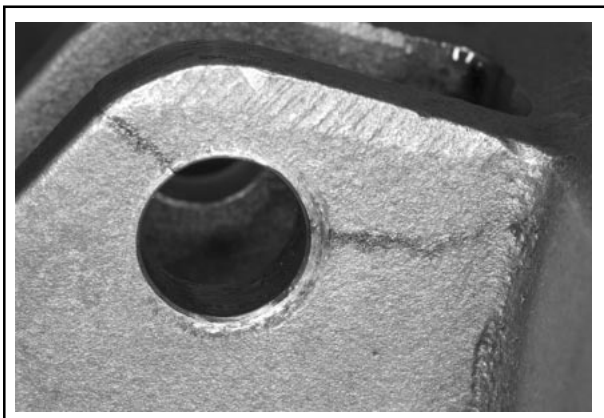
Fig. 10 Dye penetrant revealed extensive cracking in exemplar gin lug.

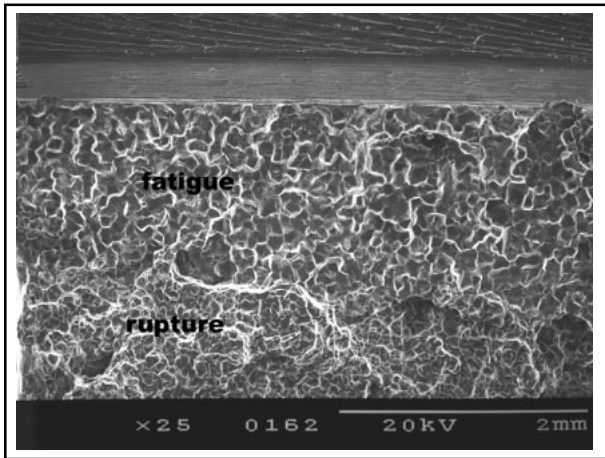
The fatigue precracked region of one of the specimens was examined with an SEM for evidence of fatigue. Figure 11 shows both the fatigue and rupture regions; Fig. 12 and 13 show more detail of each. Fatigue was clearly by intergranular fracture, while the rupture region consisted of extensive casting void regions with intergranular fracture and some rupture by large microvoids. Microvoid coalescence was not observed anywhere near the hole walls in the actual gin failure.

Fig. 11 Fatigue precrack and rupture region on one compact-tension fracture toughness specimen

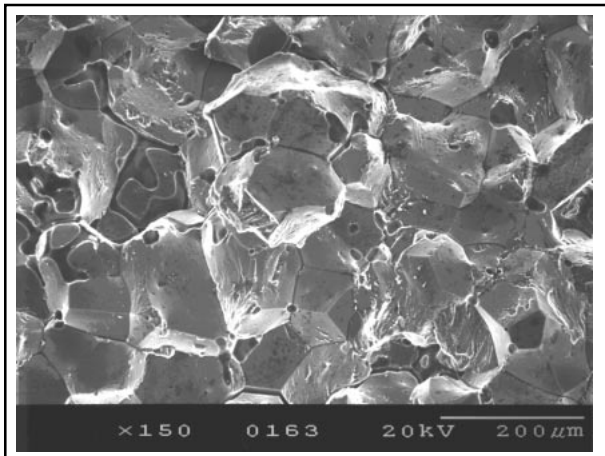
Fig. 12 No fatigue striations were observed in the intergranular fatigue area.

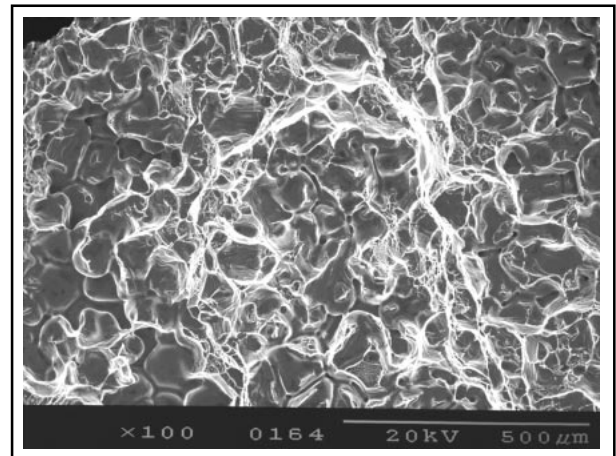
Fig. 13 The rupture region from the compact-tension specimen in Fig. 11 revealed extensive void area along with intergranular fracture and some microvoid rupture.

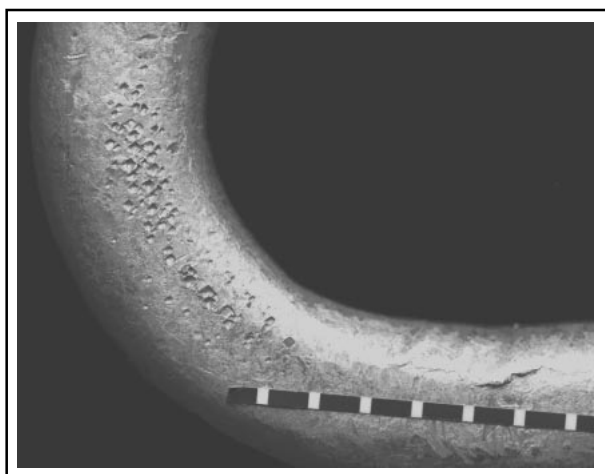
The one factor still left to be considered was abuse. A pattern of tool marks was observed on the end piece that held the shackle. Figures 14 and 15 show two of the areas with these marks. Figure 15 reveals that the marks were a regularly spaced series of truncated pyramids. Some versions of framing hammers have this type of pattern, but the tips of the pyramids are never ground off. Sheetrock hammers

Calculations of the force required to create these marks were made by calculating the area of the dents and, knowing the hardnesses of the materials,^[4] yielded force estimates on the order of 8900 N. Withdrawal loads for a 16d box nail in a building stud are approximately 2890 N,^[5] so at least that much force must be generated by a hammer blow. Therefore, the use of this type of hammer and its effects on the lug failure had to be considered. The actual arrangement of the load path of the hammer blow on the end casting to the cracked lug hole argued for attenuation of hammer blow forces. The fiberglass rod between the end and base castings would attenuate some of the force. Significant attenuation was expected by the nylon belt, which

Fig. 14 Pyramid-shaped marks found on the eye for the pulley. (Scale marker is 5.1 mm/division.)

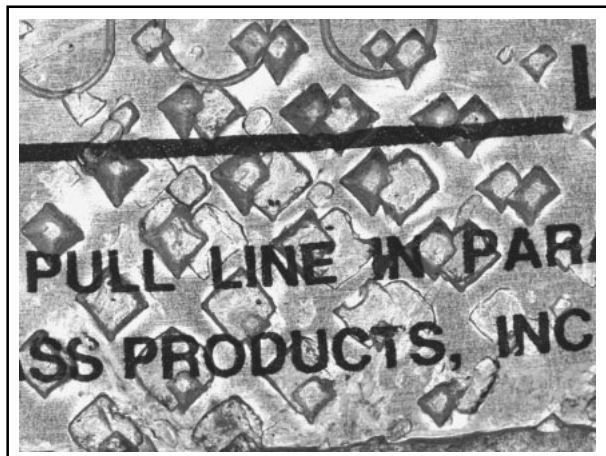
Fig. 15 The same pattern of truncated pyramids was found on a soft aluminum name plate.

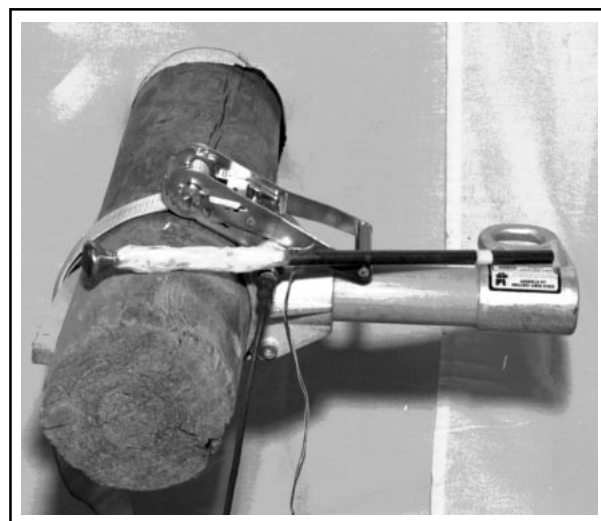
Fig. 16 Test setup for impact tests on the gin. The hammer load cell is lying on top of the gin and partially covers the clevis pin cell. The wedge used to adjust belt tension can be seen under the belt on the left side of the pole.

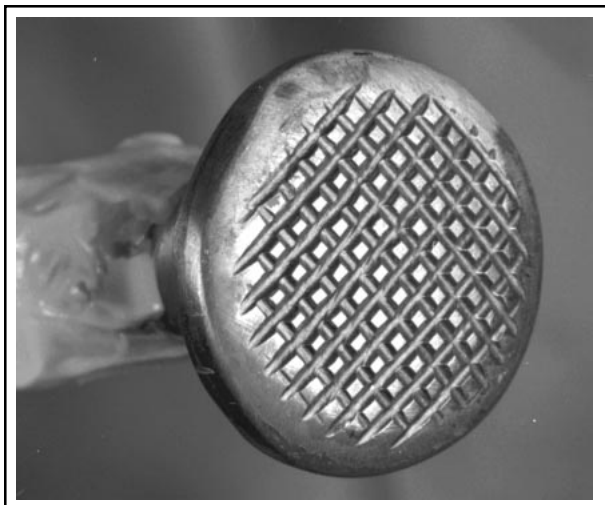
Fig. 17 Truncated pyramid pattern on the striking face of the Sheetrock hammer

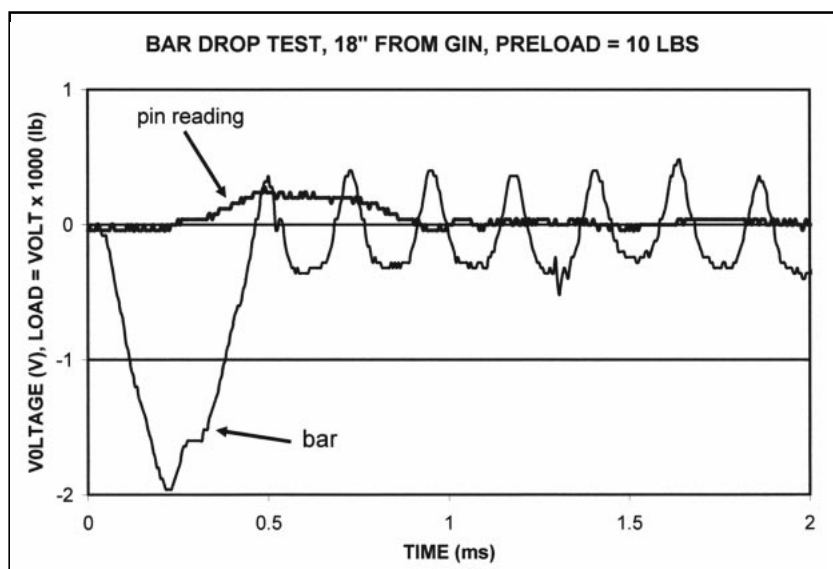
Fig. 18 Output from the clevis pin load cell for the case with 222 N belt tension. This was probably the maximum tension possible for the known conditions.
