Imperfections in Tree Stand Failures

C.K. Clarke and D. Halimunanda

Analyses of two climbing tree stand accidents are presented to show that serious imperfections in the chains would not have produced the failures had the tree stands been used within rated capacity. Stress analysis and tests demonstrated that roller chain with cracked links could operate at rated capacity without further crack growth and showed that loads approximately three times rated capacity were required to cause the pullout of an improperly staked pin. Although the chains in the tree stands involved in both accidents had serious imperfections, the imperfections did not produce a failure of the product within the rated capacity of the tree stands. However, operating conditions in excess of the rated capacity exposed the imperfections and led to the failures. Neither imperfection should have been considered a defect because they did not reduce the capacity of the tree stands below the rated capacity.

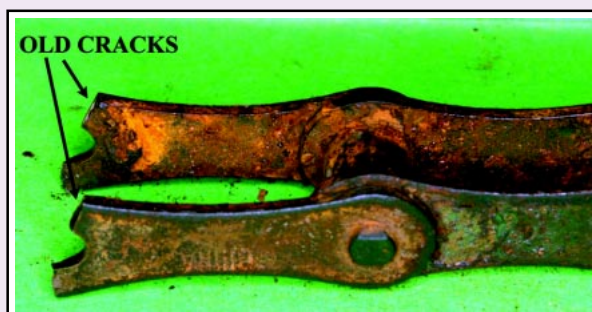
Fig. 2 Both links had old cracks at 65° to the link axis (arrows).

The first case involved a fatal hunting accident in which a pair of links were found broken. These broken links were located just outside of the side tube on the upper stand. Low-power microscopic inspection revealed that both links had old cracks through the same side of the hole wall. Both cracks were oriented approximately 65° from the link axis. Figure 2 shows the two cracked links together. The two old cracks are the top two broken hole wall ligaments. (Chain was black oxide coated.)

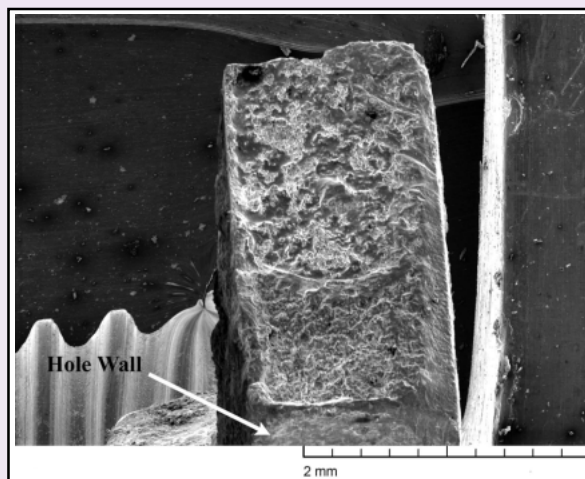
The old fracture surface on the straight link (first link to fail) was covered with corrosion (Fig. 3). Cleaning of the fracture was not permitted. However, small areas of fracture clear of corrosion could be found. Intergranular fracture was observed in all such areas. An example of the intergranular fracture is provided in Fig. 4.

Fig. 3 The old crack in the first link to fail was corroded heavily.

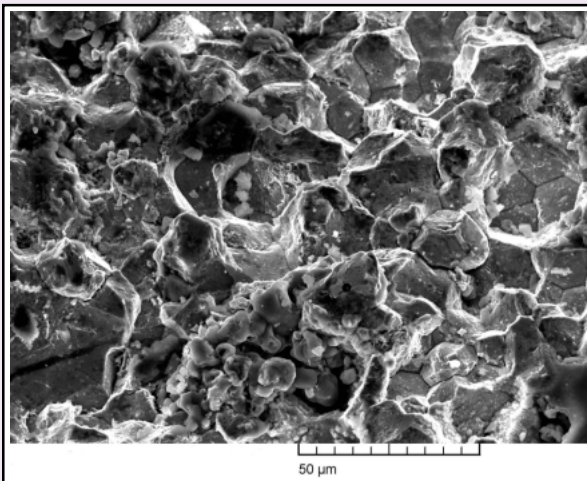
Fig. 4 Intergranular fracture in the old crack

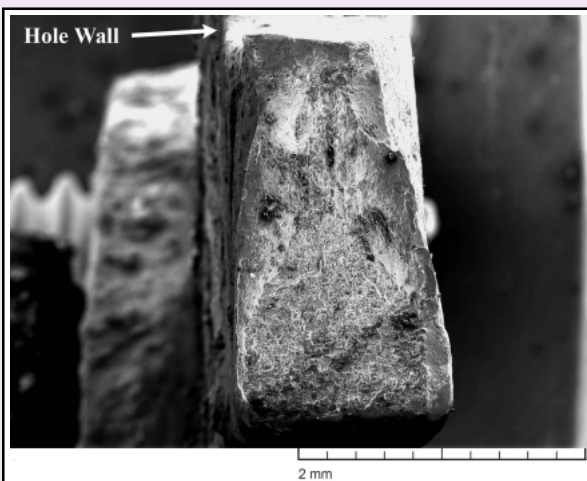
Heavy deformation was observed in the hole wall ligament opposite the old cracked ligament (Fig. 5). Substantial necking at the hole wall and heavy shear lips can be seen. Crack propagation from the hole wall was initially by shear and/or ductile tearing and finally intergranular fracture. A transition was observed from ductile tearing to predominantly intergranular fracture at approximately 50% of the width of the wall ligament. An example of the intergranular fracture is provided in Fig. 6.

Fig. 5 Heavy necking at the hole wall surface and shear lips on the rupture surface

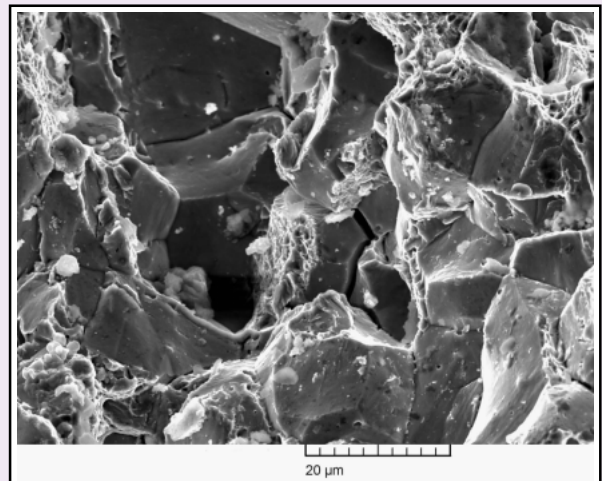
Fig. 6 The flat fracture seen in Fig. 5 was mostly intergranular.

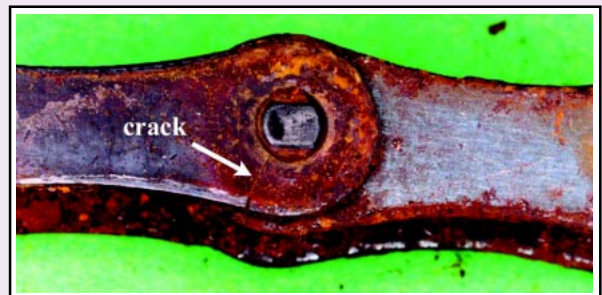
Inspection of the rest of the chain from the upper stand revealed a cracked link at the tail end of the chain. The design of the stand and the location at the link are such that this cracked link (Fig. 7) could never have been loaded. The chain was unusually rusty both at this location and at the fractured links. Chains come from the factory with a light coating of oil and are covered with heat shrink tubing. Traces of chlorine were found in some of the rusty areas. Little history was available on how the tree stand had been stored before the accident. Field corrosion tests on similar chain in a seacoast environment failed to produce the degree of corrosion

Fig. 7 This cracked link was found in the end of the chain where no operating loads could have been placed on it.

No evidence was found for low-cycle fatigue, which should have resulted in incremental crack growth with little necking or reduction in area. Conventional stress calculations based on the hunter's weight for hooks^[2] (a chain link with a crack such as shown in Fig. 7) showed elastic stresses approximately twice the tensile stress in the opposite hole wall. However, these stresses are primarily bending stresses, and plastic redistribution of the stresses will occur. Hole wall stresses of this magnitude indicate that the hook was at or near proof load conditions.^[2] A reconstruction test using saw cut links was run to verify the predictions from the calculations.

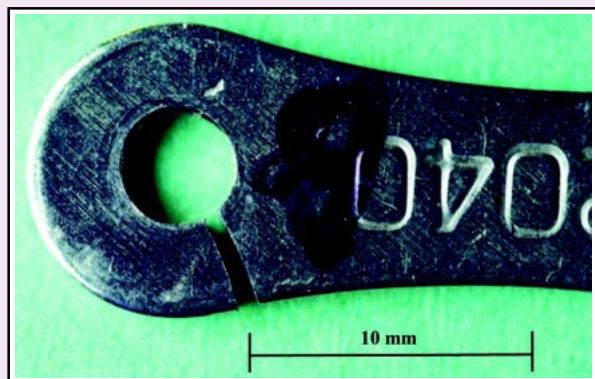
Saw cuts were put into exemplar links from another chain source that had a hardness of 40 HRC and was thus softer and had a lower yield strength than the accident links. Both cuts were made at the same location and orientation as the old cracks seen on the failed chains. The stand was loaded to the equipped weight of the hunter, 1070N (which was close to rated capacity 1220N), under conditions duplicating the tree diameter at the time of the accident. No deformation was observed in either link after two tests (Fig. 8).

This test validated the hook stress calculations and demonstrated that higher forces than would be expected in normal use were required to break the already cracked links. The tests also confirm that the stand could have been used successfully with cracked links. Thus, while the old cracks were glaring imperfections created some time before the accident, they were not the proximate cause of the accident. There had to have been an additional source of loading.

Fig. 8 One of the exemplar links after testing shows no deformation or opening of the saw cut.

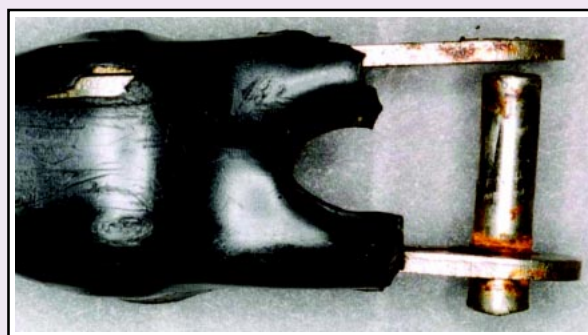
The second case involved a slightly different design for a climbing stand but the use of the double pitch roller chain was the same. A separated chain was found at the accident site. Close examination revealed that a pin had pulled out (Fig. 9). Pins are normally "staked" or upset with two opposing flats on each pin end. The end that pulled out did not show obvious evidence for any stake, while the opposite end had one heavy stake (Fig. 10). The end that pulled out was partially hidden and could not be examined directly because destructive testing was prohibited.

Fig. 9 The pin pulled out of an outer link plate in this failure. The bottom end of the pin was clearly upset while the top was not.

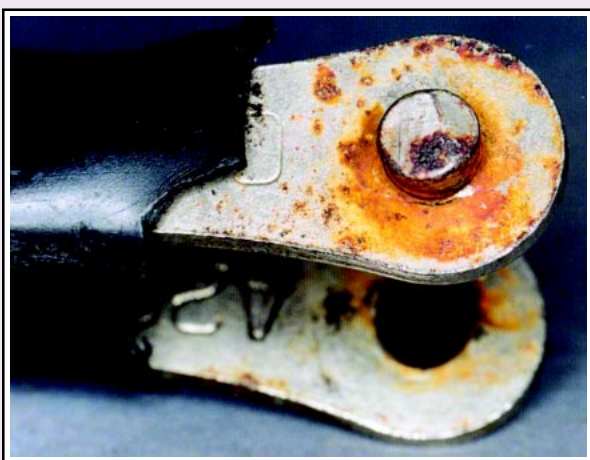
Fig. 10 A view of the bottom head in Fig. 9 shows a large, single indentation in the head.

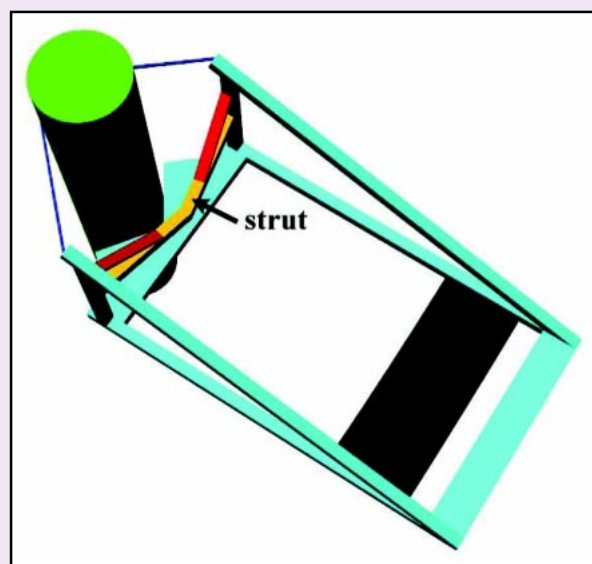
A transverse strut strengthening the two side arms was observed to be bent. This bending is illustrated in Fig. 11, which has the bend exaggerated for clarity. The nature of the sharp bend, stand design, and location of the strut made it unlikely that

the bend was produced by the hunter falling on the strut.

Fig. 11 The arrangement of the tree stand with the bent strut

duce both bending and compression in the strut. This condition was analyzed using the secant formula for columns.^[3] Actual plastic collapse is not well defined for this situation, but using elastic stresses 50% over the yield stress as a starting point for plastic collapse yielded a stand load of at least 3560N. This is in reasonable agreement with the tests on a similar stand. The hunter's weight was approximately 750N.

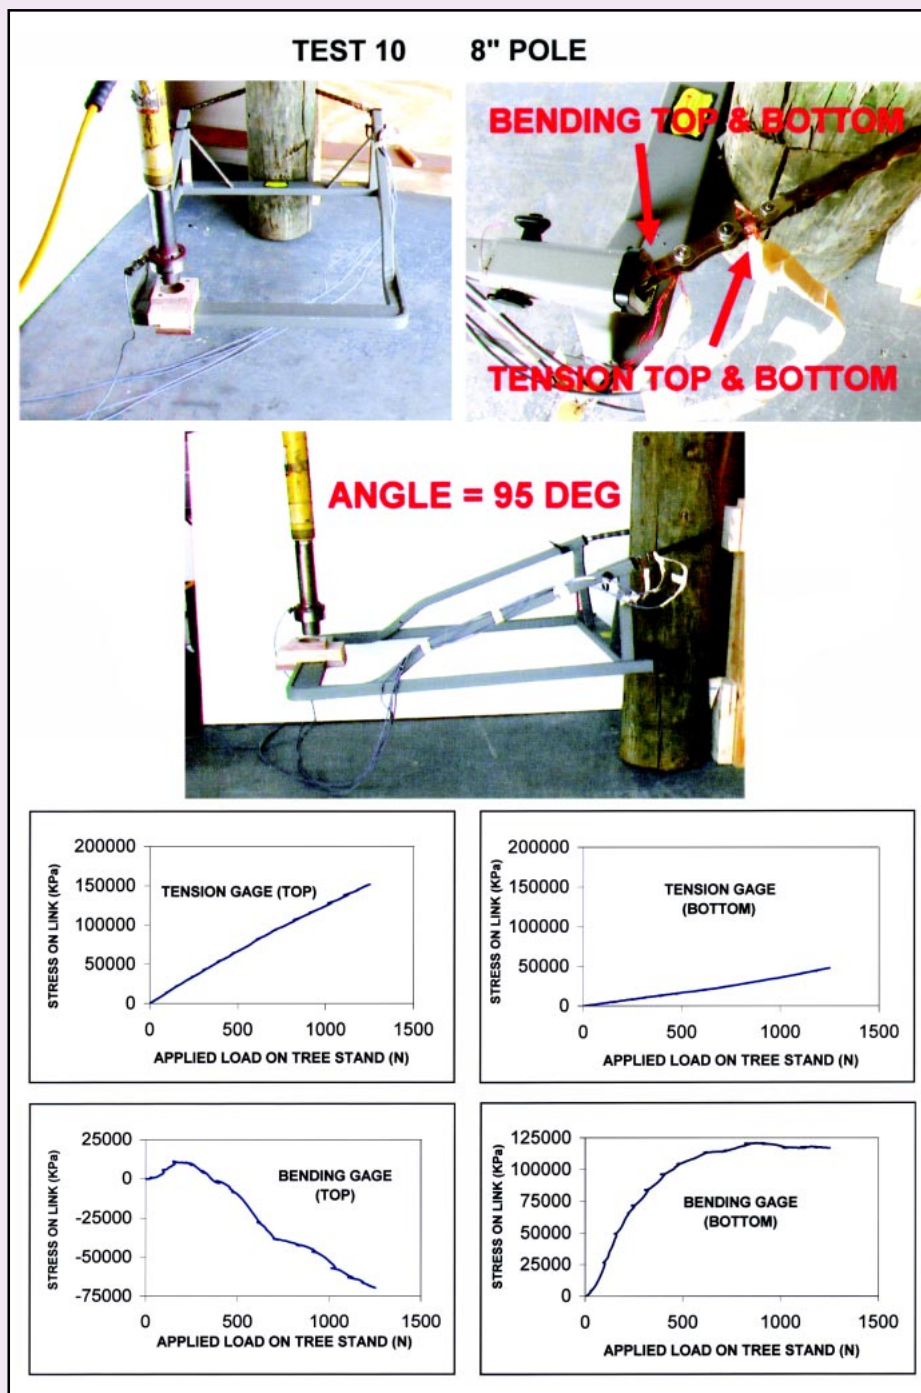
side tubes and whether the link was on the top or bottom. Bending stress links just exiting the side tube yielded the highest bending stresses (120 MPa). The direction or the sign of the bending stress was opposite in the two links, with the lower link having a higher and positive value. Tensile stresses of 269 MPa were measured in the top tension link just exiting the side tube. The bottom tension link produced less than half this value. Tension stresses dropped much faster than bending stresses as the gages were moved away from the side tube exit hole. The maximum combined stress at 1250N load (rated capacity was 1220N) was 338 MPa. These stresses are in the waist or middle of the link. Stresses in the hole wall ligaments are slightly higher because the area is slightly less. Using an elastic stress concentration factor of 3.4 (finite width plate) produces hole wall stress estimates near yield at the corners of the hole walls. (Bending stresses are only present on the surfaces.) Thus little deformation of the hole wall would be expected.

Actual tests were run with a similar but larger seat frame because no exemplars for this particular model were available. This larger frame should have increased forces on the links on this stand because the leverage and angles were larger. Figure 12 shows the setup and data from the tests with the highest bending stresses.

Fig. 12 Sample data from the tree stand show that forces and stresses depend on location. Bending stresses were never linear with applied load.

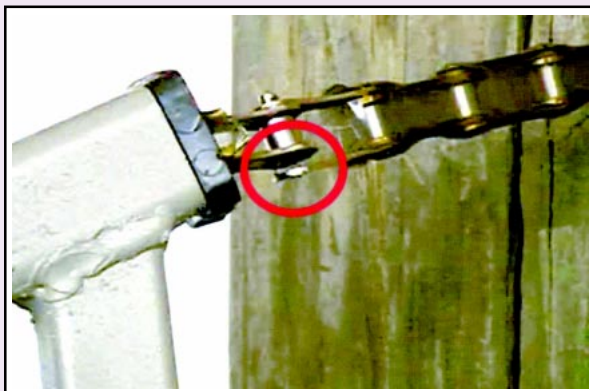
Tests were run to determine the effect of a pin with no upset or staking on one end. One pin end was ground flush to duplicate lack of staking. Using this pin on a tree stand produced no pullout. A test was then run with the pin driven out of the two bottom links at 4000N load. Figure 13 shows the pin clear of the link and stable at 4000N. The bottom link location was chosen because of higher bending stresses. This stand (test stand design shown in Fig. 1) was bent as a result of the force component in the tubes toward the centerline of the stand. Bending of the strut on the accident stand was similar in nature. While the stand in this case had two transverse members, the overall stiffness was similar.

found could still support loads adequate to deform the stand, 4000N. Normal load for this stand and hunter was approximately 750N.

Fig. 13 A link with the pin driven clear of two links is shown to be stable at 4000N load and with little deflection or deformation.
