Wheel Stud Bolt Failures

Three culprits—improper seating, deformed threads, and use of noncalibrated torque wrenches are addressed below.

C. Kendall Clarke, PhD, P.E.
Metallurgical Consulting, Inc.
1146 Le Roy Stevens Rd., Suite A
Mobile, AL 36695

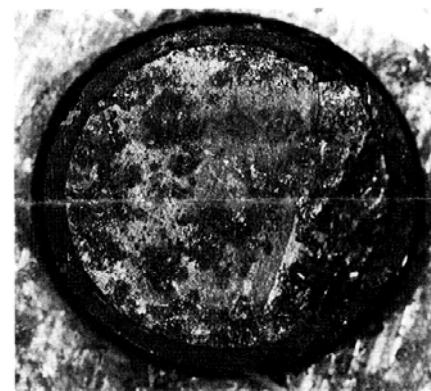
Evaluation of the broken stud bolts revealed fatigue in all fractures. **Figure 1** shows one of the better preserved fractures. The stud bolts were also observed to be aftermarket bolts and four out of five were not properly seated.

Fig. 1 — This wheel stud bolt from a passenger car has a fatigue crack across 75% of the fracture surface.

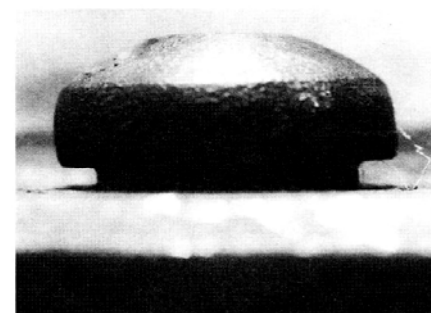
Figure 2 shows a profile view of one unseated bolt. Fatigue fracture covered 90-100% of the fracture surface in three of the bolts. The one seated bolt had 75% of its fracture surface composed of fatigue bands and the last bolt had 40% fatigue coverage.

Fig. 2 — Four out of five wheel stud bolts were clearly not properly seated.

Failure to properly seat the stud bolts was the probable cause for fatigue failure of the bolts. This is an important conclusion because stud bolts appear to be replaced more often than was generally recognized. Most shops recognize that presses should be used to install such bolts, but one car manual recommends using lug nuts to seat the bolts. Limited testing reported here makes that approach highly questionable.

- **Culprit 1** — Improperly seated wheel stud bolts in passenger cars and trucks may present a more serious safety hazard than earlier recognized. Wheel stud bolts are not always properly seated when replaced by mechanics. Improperly seated stud bolts can lead to fatigue failures. Stud bolts must be seated by a hydraulic press.

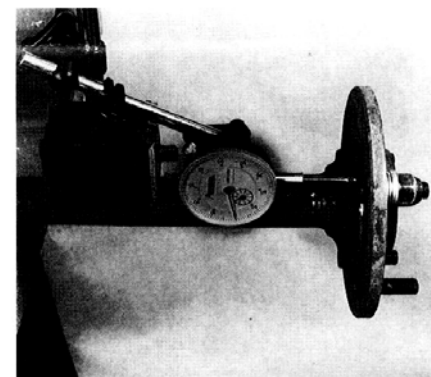
Fig. 3 — A dial gage was used to monitor movement of the bolt head while the nut was run down with a torque wrench.

The effect of improperly seated stud bolts was investigated with another axle removed from a similar sedan. It also had similar aftermarket stud bolts improperly seated. As a matter of fact, additional investigation revealed a considerable number of aftermarket stud bolts on axles that could be inspected. A dial gage was set up on the head of the bolt and a nut with hardened washers was used with a torque wrench to try to seat the bolts. Threads were cleaned and lubricated. That setup is shown in **Figure 3**.

All unseated stud bolts moved at 75 ft.-lbs. Two bolts seated at 140 ft.-lbs., and the threads stripped in the third at 130 ft.-lbs., without seating. Had a tire been mounted on this axle, and nuts installed with a torque wrench, full clamp-up could have been achieved if the nuts were torqued to 70 ft.-lbs., but could have moved the stud bolt and destroyed the clamp-up. Failure to seat the stud bolt heads hard against the axle flange results in unpredictable clamp-up and the possibility of fatigue failure of the stud bolts.

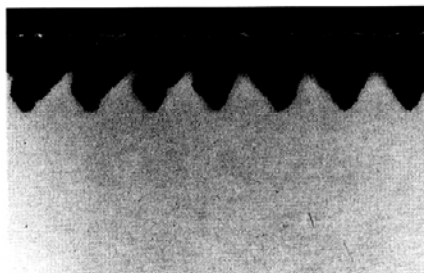
Fig. 5 — Both undamaged and damaged threads can be seen in this section through one of the broken wheel stud bolts from the truck. Thread damage in both directions was observed. This thread damage destroys the normal thread clearances and renders any torque measurements useless.

Thread profiles on all bolts were observed to be deformed. The bolts which had high-cycle fatigue and were the first to break had the most thread damage. **Figure 5** shows the thread profile from one of the broken stud bolts.

nuts were over-torqued the first time and threads were deformed. The air wrench used the second time had the power to remove the nuts. However, there was no way to reinstall the nuts properly because the damaged threads provided too much turning frictional resistance. Thus about half of the wheel stud bolts probably had little or no clamp-up and failed quickly. The remaining bolts failed under the greatly increased forces.

- **Culprit 2** — Deformed threads from over-torquing wheel stud nuts constitute a serious problem for all vehicles. This problem is that a prior tire installation, with over-torque damaging the threads, makes a later installation impossible to perform correctly. Thread gages are now readily available for the three-piece wheel bolts that are used on large trucks. Similar type gages available for passenger cars would be very helpful.
