Evaluation of a Leaf Spring Failure

C.K. Clarke and G.E. Borowski

The determination of the point of failure during an accident sequence of a rear leaf spring in a sport utility vehicle is presented in terms of fracture surface analysis and residual-strength estimates. Marks at the scene of the accident pointed to two possibilities for the point of failure: marks in the roadway at the start of the accident sequence and a rock strike near the end of the sequence. Evidence from rust and chemical contamination on the fracture pointed to the spring having been cracked in half prior to the accident. Extensive woody fracture and secondary cracking at the midplane of the spring was evidence for segregation and weakness in the spring. Stress estimates for the effect of both the weakness and prior cracking on the residual strength of the spring revealed reductions in strength of the spring that could produce fracture at the start of the accident sequence. The point of failure of the spring was placed at the start of the accident sequence.

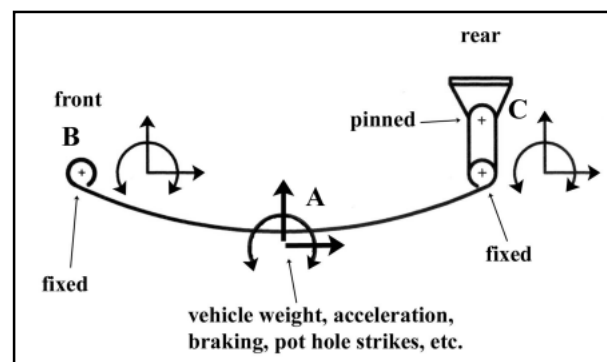
Fig. 20 Reaction forces on the spring eyes in the vehicle are complex. Both spring eyes can develop moments through the rubber grommet. The link at "C" is free to rotate. Longitudinal forces develop at "A" from both direct longitudinal forces and moments from the tire to the spring.

frame. The ALGOR program modeling this arrangement revealed that the rubber properties had a significant effect on the spring stresses at the point of failure. The program also predicted higher stresses at the end of the first helper leaf than at the spring eye. This is consistent with the Society of Automotive Engineers' spring-design manual.^[10] Stresses at the spring eye should be low, according to the spring manual. Different cases were run with different assumed rubber properties, because the actual properties were not known. These cases revealed that transverse tensile stresses did occur at the midplane, and their magnitude depended on the compliance of the rubber and the fixity of the bolt collar. These calculations help to explain the tensile nature of the woody fracture and provide a source of service stresses that could produce delamination.

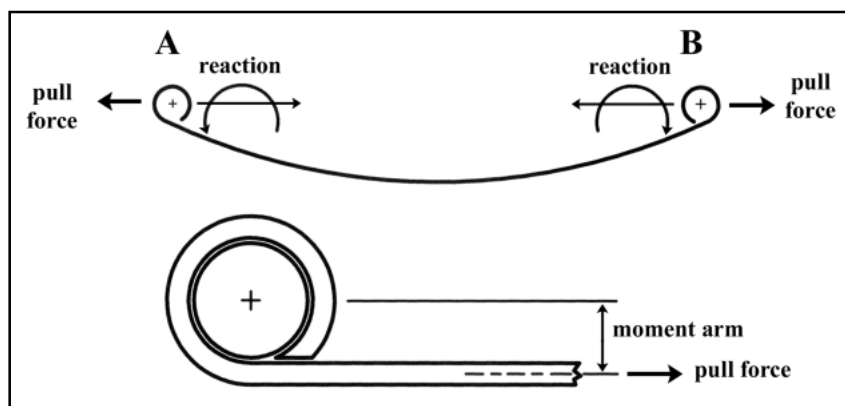
Residual-strength calculations were made with longitudinal forces only, because they simplified the calculations, and pull test data were available for comparison. Use of longitudinal forces only does provide a meaningful analysis of the spring failure, because reaction forces at the spring eye from pothole strikes and moments from the tire-axle housing-spring connection produce longitudinal forces. Figure 21 shows these forces on the spring eye.

Fig. 21 Reaction forces in the spring eyes were simpler by the very nature of the pull test. Spring curvature was neglected because the spring straightened out early in the test. Bending stresses were based on the spring eye radius.

reasonable measure of reduction in strength. (An elastic-plastic analysis was beyond the scope of the project.) Using this approach, the force to reach 1460 MPa was estimated to be 23,000 N for no delamination and 10,200 N for the observed delamination in the accident spring. Using 48,200 N pull to failure from test results on exemplar springs yielded a 52 to 79% reduction in spring strength. These numbers demonstrate the serious reduction in strength possible for both the small crack and the delamination. (Small cracks in hard or high-strength steels are well known for severely reducing the strength.) Evidence of the outer half being cracked for some time indicates that the reduction in strength did in fact occur.
